**Flood Control Project Maintenance
Levee Inspections**

Maintenance Issue Types Only, Levee Inspection Report By Mile - Spring 2018

Reclamation District No. 0404 Boggs

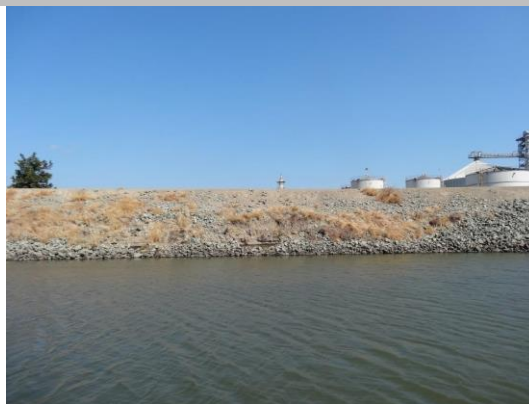
Photo 1 of 3 : SP_2018_RD0404_305_6_20180323_00002.jpg

| 09/13/2017: The erosion is located between two protected levee sections. [2017 Site ID:RD0404U01RM41.05] | | | | | |

Front view of the erosion.

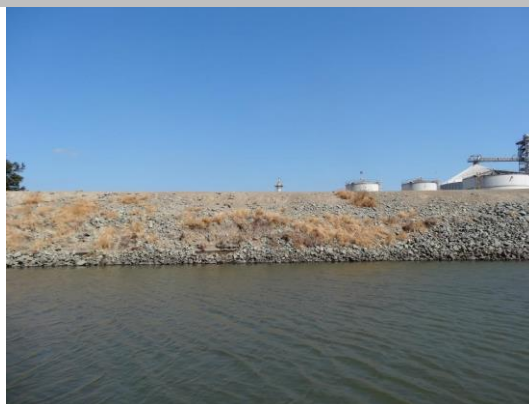
Photo 2 of 3 : SP_2018_RD0404_305_6_20180323_00003.jpg

Front of the erosion.

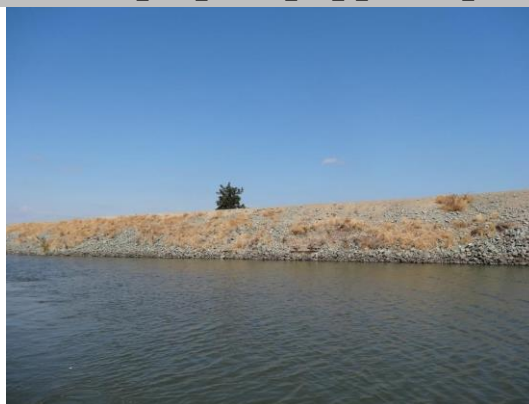
Photo 3 of 3 : SP_2018_RD0404_305_6_20180323_00004.jpg

Looking downstream at the erosion site.

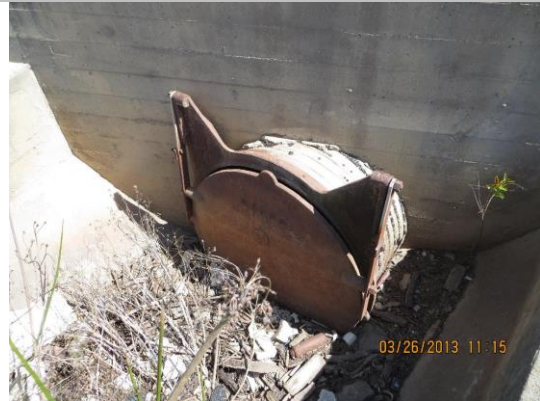
Photo 2 of 3 : UCIP_SP_2018_52607_19962.jpg

11/29/2016 Flap gate still buried with sediment on WS. Requires clearing. (K. Fazel - UCIP)03/26/2013 Partially buried flap gate (P. Amatya - DWR)
FIELD_STRUCT_DESC: 42-inch corrugated metal drainage discharge pipe, 18 feet below the crown. Flap gate, concrete headwall, and spillway on the waterside (WS). Pump house on the landside (LS). Abandoned concrete headwall, power pole, and two wooden piles found on the LS. This drainage pipe likely belongs to the City of Stockton. [Additional Reference(s): DWR Levee Log, 2006. USACE San Joaquin O&M Manual 1, March 1963, (HLM 0.78)].
FS Date: 11/22/2017

WS- drainage outlet structure and CM pipe with flapgate

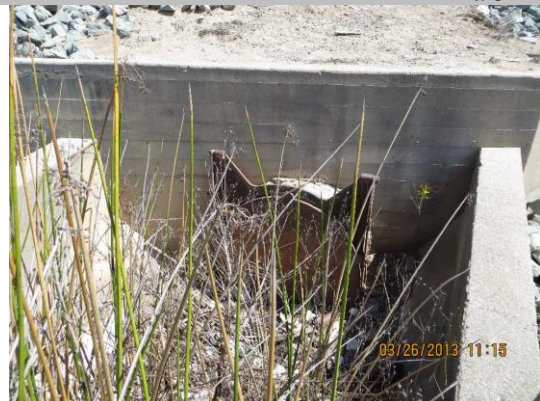
Photo 3 of 3 : UCIP_SP_2018_52607_19961.jpg

WS- Debris and vegetation blocking CM drainage pipe

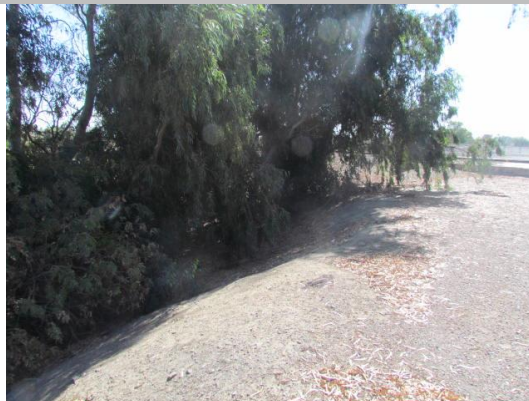
Photo 1 of 1 : SP_2018_RD0404_305_8_20180323_00005.jpg

| Trees are blocking view of the slope. | | | | | |

Looking southeast at dense trees on landward slope and toe.

| T1 : Trim trees to at least five feet above ground level. | | | | | |

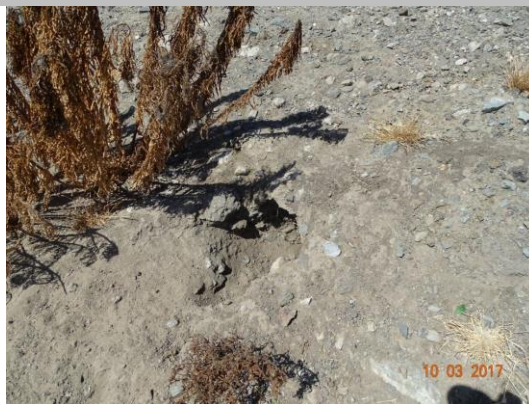
Photo 1 of 2 : SP_2018_RD0404_305_42_20180323_00018.jpg

View of the waterside slope looking southwest.

| A3 : No rodents visible, but rodent burrows visible; need to backfill and compact or grout burrows. | | | | | |

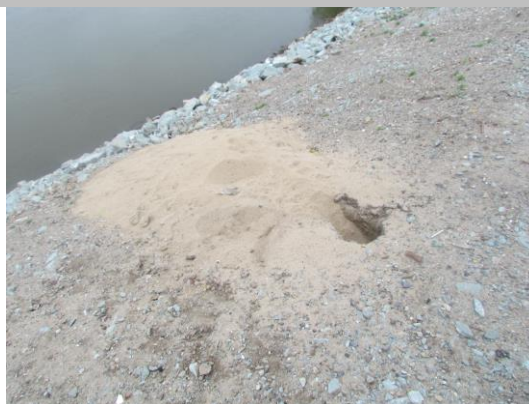
Photo 2 of 2 : SP_2018_RD0404_305_42_20180323_00019.jpg

Looking northwest at large animal hole (den) on waterward shoulder.

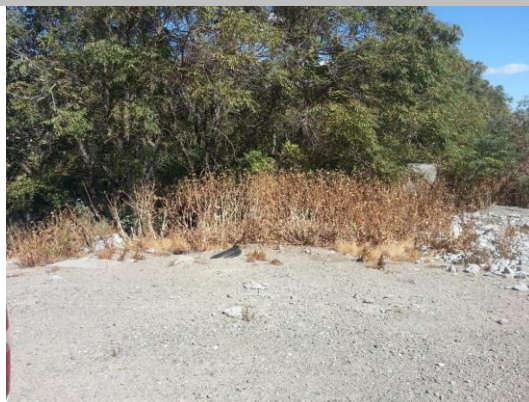
Photo 1 of 2 : SP_2018_RD0404_305_101_20180323_00021.jpg

| Dense vegetation on landward slope. | | | | | |

Looking east at dense vegetation on landward slope. (Fall 2016)

| V2 : Remove the wild growth other than native grasses from the levee slopes. | | | | | |

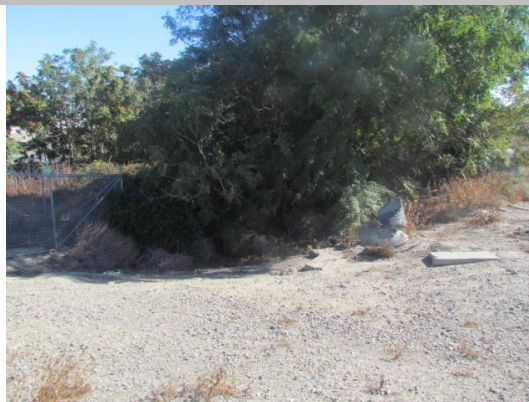
Photo 2 of 2 : SP_2018_RD0404_305_101_20180323_00022.jpg

Looking southeast at overhanging trees on landside slope. (Fall 2015)

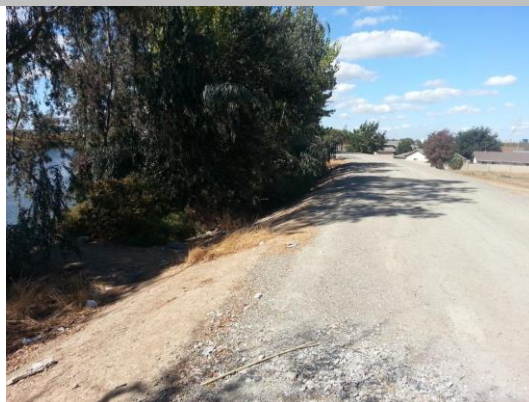
Photo 1 of 1 : SP_2018_RD0404_305_100_20180323_00020.jpg

Looking northwest at untrimmed trees on waterward slope.

| T1 : Trim trees to at least five feet above ground level. | | | | | |

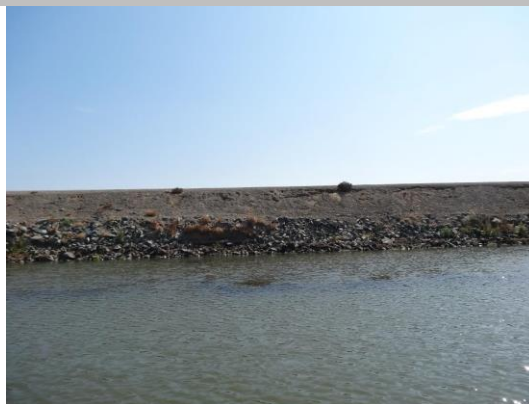
Photo 1 of 2 : SP_2018_RD0404_305_11_20180323_00006.jpg

| 06/19/2014: A series of scarp erosions have been found on the lower levee slope and at the levee toe. [2017 Site ID:RD0404U01RM42.02] | | | | | |

Front view of the erosion.

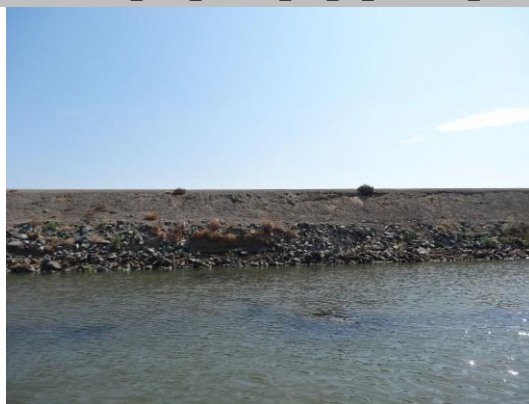
Photo 2 of 2 : SP_2018_RD0404_305_11_20180323_00007.jpg

Close view of the erosion. Note the protection on the lower levee slope.

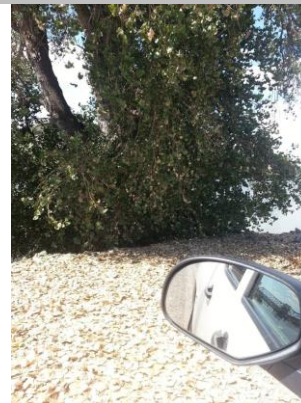
Photo 1 of 1 : SP_2018_RD0404_305_27_20180323_00013.jpg

Looking west at untrimmed trees on waterward slope.

| T2 : Thin trees to allow visibility of the ground and room to flood fight. | | | | | |

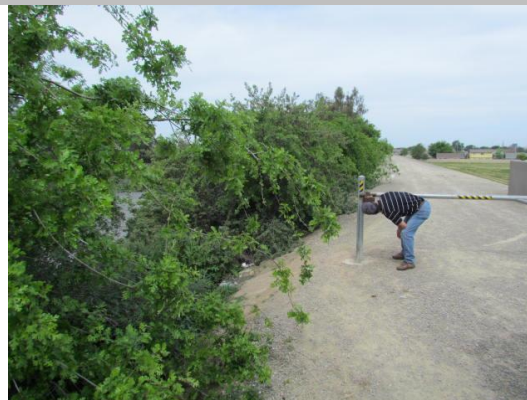
Photo 1 of 2 : SP_2018_RD0404_305_29_20180323_00014.jpg

| Dense untrimmed trees on waterward slope. Army Corp veg site.Tree and woody vegetation planted by the DWR but not being maintain according to agreement. | | | | | |

Looking north at dense vegetation on waterward slope.

| T1 : Trim trees to at least five feet above ground level. | | | | | |

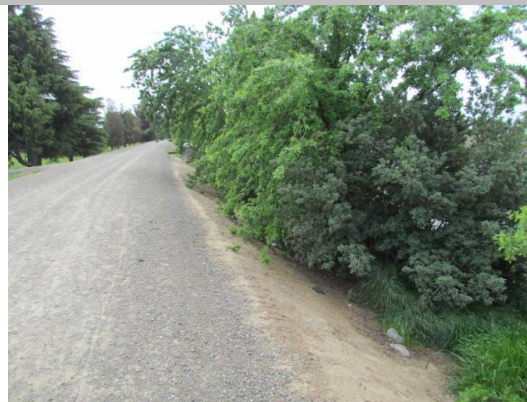
Photo 2 of 2 : SP_2018_RD0404_305_29_20180323_00015.jpg

Looking south at dense vegetation on waterward slope.

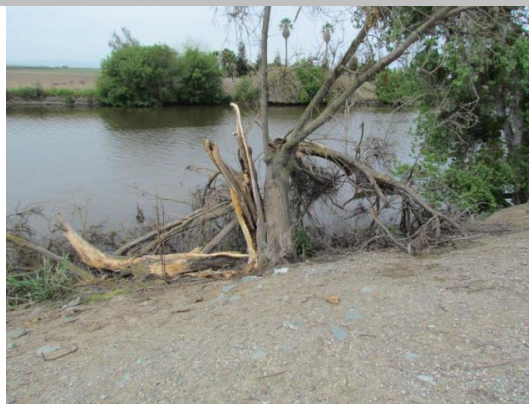
Photo 1 of 1 : SP_2018_RD0404_305_33_20180323_00016.jpg

| Dead tree on waterward slope | | | | | |

Looking west at dead tree on waterward slope.

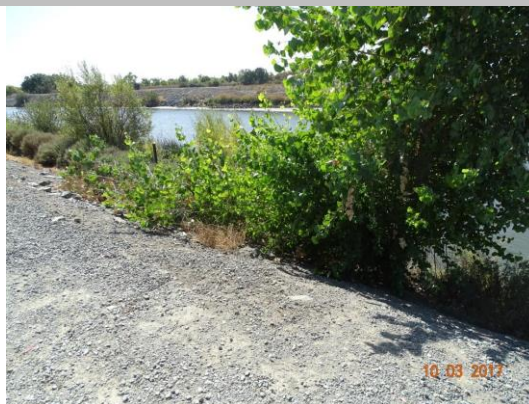
Photo 1 of 1 : SP_2018_RD0404_305_22_20180323_00011.jpg

View of the waterside slope looking south.

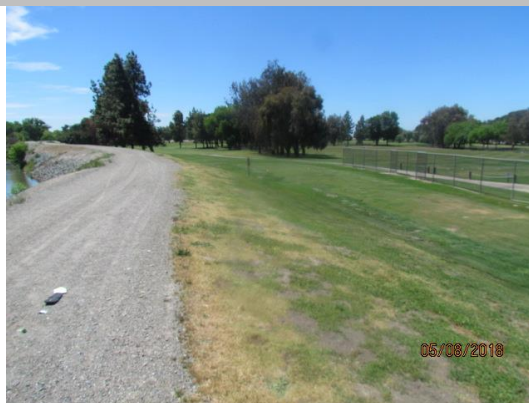
Photo 1 of 1 : SP_2018_RD0404_306_9_20180511_00027.jpg

| District is maintaining annual grasses and weeds. | | | | | |

Looking downstream at typical view of landward slope. (Spring 2018)

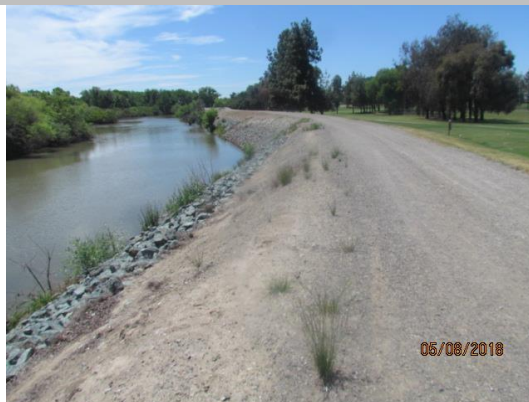
Photo 1 of 1 : SP_2018_RD0404_306_10_20180511_00026.jpg

| District is maintaining annual grasses and weeds. | | | | | |

Looking downstream at typical view of waterward slope. (Spring 2018)

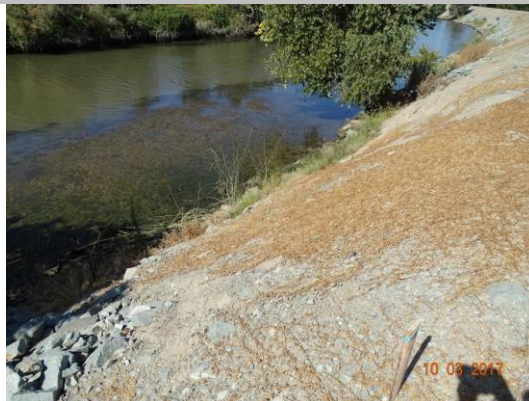
Photo 1 of 2 : SP_2018_RD0404_306_14_20180323_00003.jpg

| Erosion occurred winter 2017. | | | | | |

View of the waterside slope looking northwest.

| E2 : Schedule repair of erosion site prior to the next inspection. | | | | | |

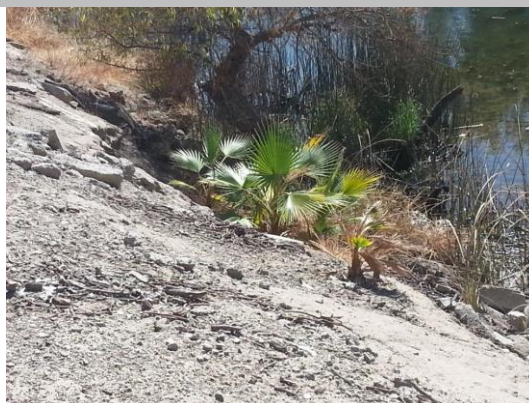
Photo 2 of 2 : SP_2018_RD0404_306_14_20180323_00004.jpg

Looking southeast at erosion on waterward slope.

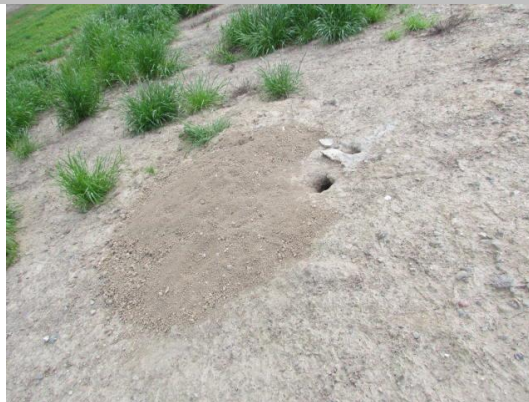
Photo 1 of 2 : SP_2018_RD0404_306_21_20180323_00009.jpg

| Large holes noted on landward slope. | | | | | |

Looking northeast at large rodent hole on landward slope.

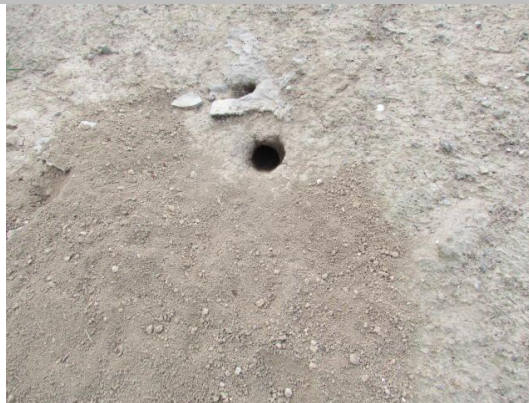
Photo 2 of 2 : SP_2018_RD0404_306_21_20180323_00010.jpg

| Large holes noted on landward slope. | | | | | |

Looking east at large rodent hole on landward slope.

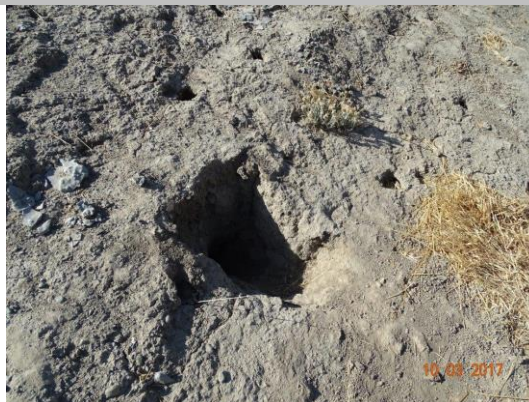
Photo 1 of 4 : SP_2018_RD0404_306_20_20180323_00005.jpg

| Large rodent holes on landward slope and levee crown. | | | | | |

View of the landside slope looking north.

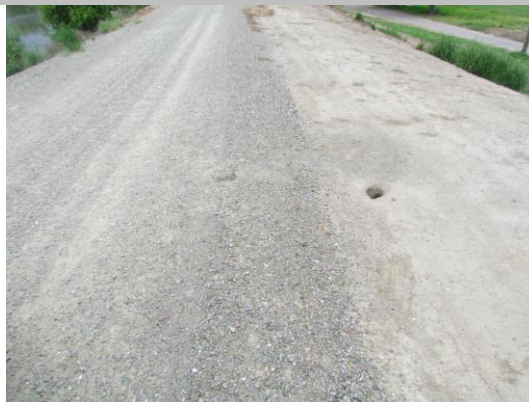
Photo 2 of 4 : SP_2018_RD0404_306_20_20180323_00006.jpg

Looking northeast at rodent hole on landward shoulder.

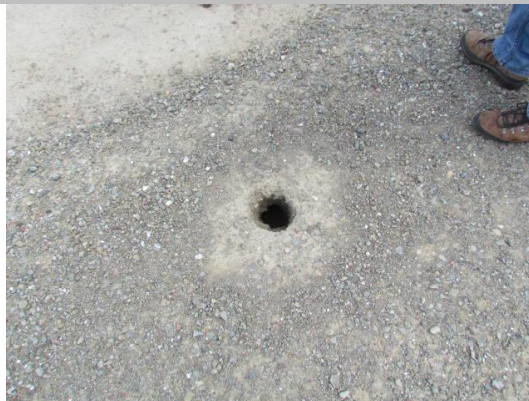
Photo 3 of 4 : SP_2018_RD0404_306_20_20180323_00007.jpg

| Large rodent holes on landward slope and levee crown. | | | | | | |

Looking at rodent hole on levee crown.

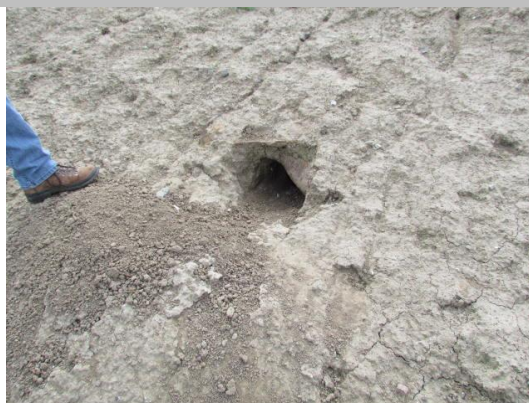
Photo 4 of 4 : SP_2018_RD0404_306_20_20180323_00008.jpg

Looking at rodent hole on landward slope.

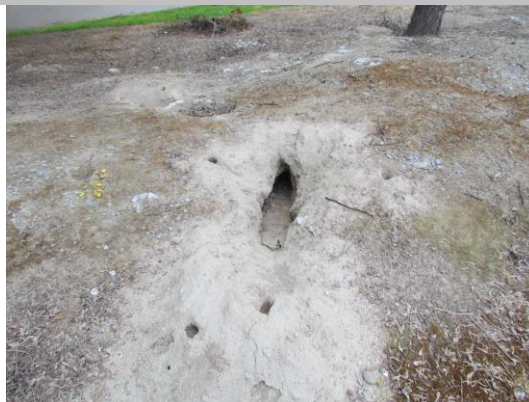
Photo 1 of 2 : SP_2018_RD0404_306_11_20180323_00001.jpg

| Grouting program is being used but is not effective. | | | | | |

Looking east at large rodent hole on landward slope.
